STRUCTURAL STABILITY EVALUATION, POKEGAMA DAM.(U)

MISCELLANEOUS PAPER SL-80-15

## STRUCTURAL STABILITY EVALUATION POKEGAMA DAM

September 1980

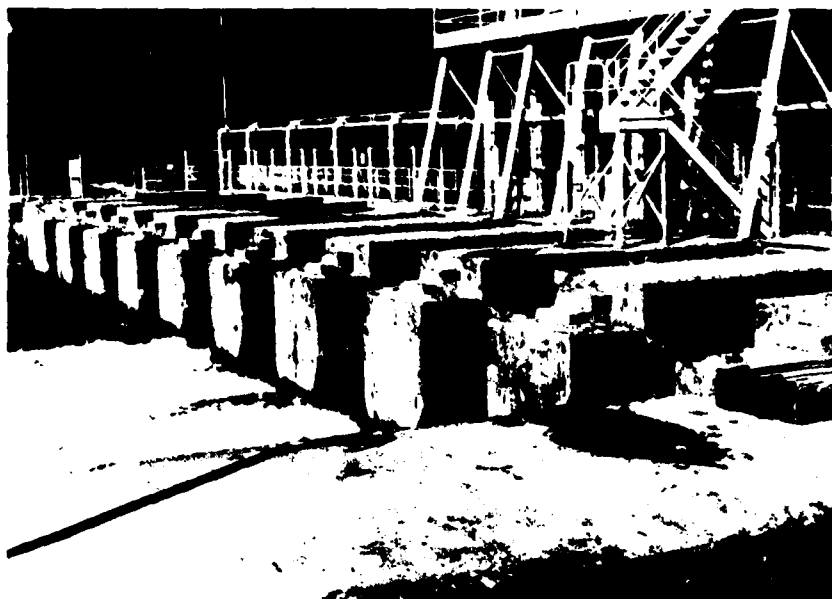
51. In general, the 77-year old surface concrete of Pokegama Dam is in excellent condition. The core did not indicate any depth of deteriorated concrete. Minor freezing and thawing deterioration of the surface concrete exists mainly at the corners of the downstream ends of piers. The deteriorated surface concrete is not significant structurally, but it should be economically repaired in order to prevent the entrance of water into cracks, thus reducing the present freezing and thawing, which produces deterioration at an accelerated rate.

a. Downstream end of piers

62. The small amount of deteriorated concrete, mainly at the ends of the piers, should be repaired in order to prevent the entrance of water into cracks, which produces deterioration at an accelerated rate.

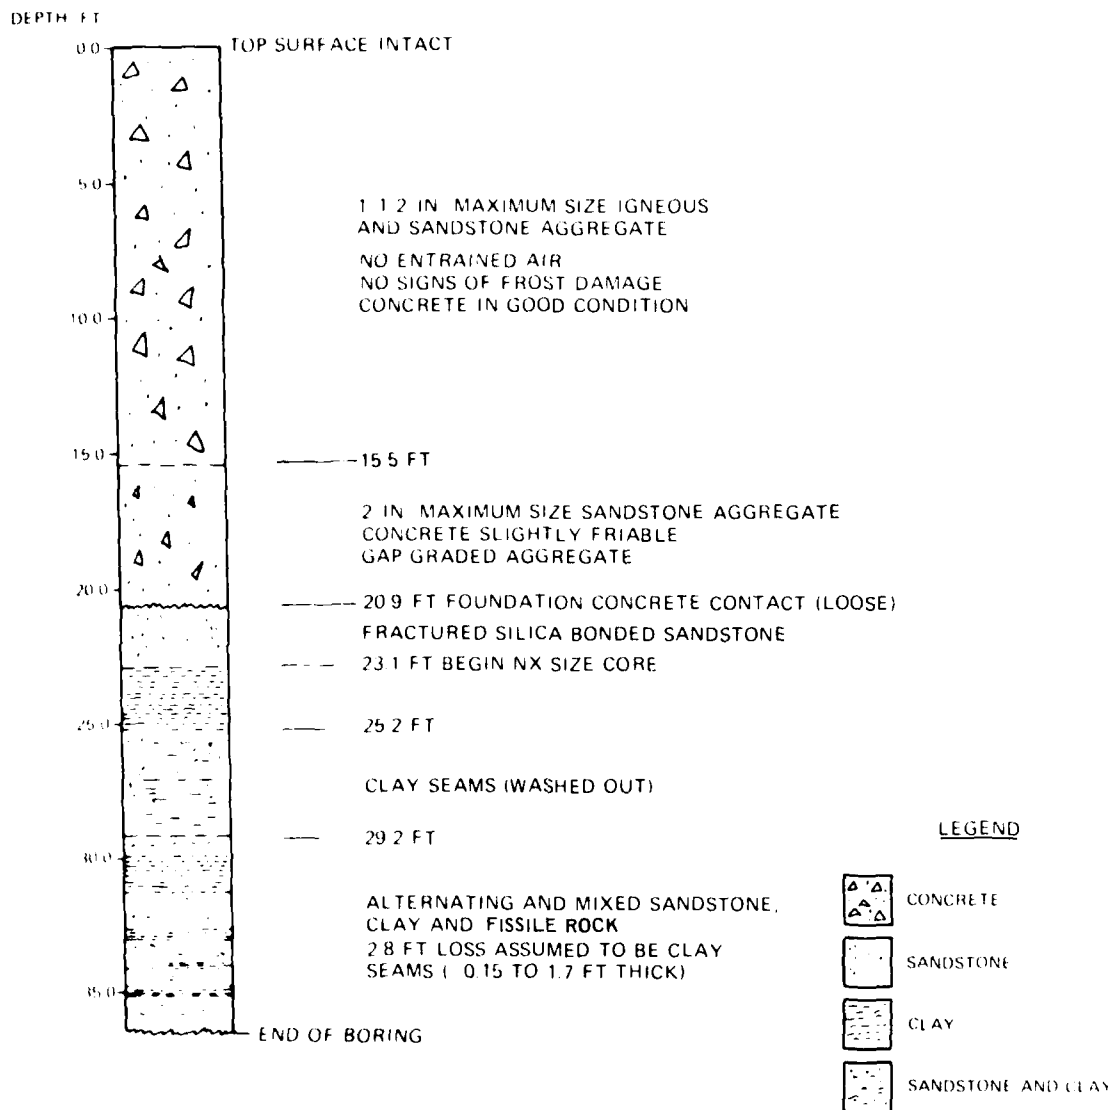
Figure 10. Core log for P-P4

28. The foundation rock consisted of silica bonded sandstone grading to quartzite and hard intact sandstone grading to friable sandstone mixed with reddish clay (Figure 10). A sample of the clay consisted of clay-mica with some smectite\* and kaolinite.

30. A large amount of the major clay seam shown in Figure 10 was found in core P-P4, which was a longer core. Very little of the clay was recovered; it was located approximately as shown in Figure 10. The evidence for this was the change in drill water color, drill rig response to the material, and inability to recover the core.\*\* The major clay seam was located at a depth of 25.2 to 28.6 ft in boring P-P4. The material below this depth consisted of alternate beds of sandstone and clay with some intermixing of fissile rock.

46. The foundation material in core P-P4 exhibited closely spaced bedding planes with the inclusion of clay seams. The first 4.3 ft was sandstone without clay seams. The next 4 ft was clay, of which 2.1 ft was completely washed away by the drill water. After the 4 ft of clay, core P-P4 exhibited thin clay seams and sandstone foundation material. The clay seams were less predominant with depth.

60. The monoliths of Pokegama Dam are adequate in their resistance to overturning, sliding, and base pressure if the clay seam does not cause a stability or underseepage problem. It is recommended that additional drilling be performed in the area of pier 4 to determine the extent and nature of the clay seam in order to evaluate its effect on stability and underseepage. If after additional drilling, the clay seam is determined to be extensive enough that a stability or underseepage problem exists, remedial measures must then be accomplished.
